**BUREAU OF SHIPS GROUP  
TECHNICAL INSPECTION REPORT**

**U.S.S. RALPH TALBOT (DD-390)**

**TEST ABLE**

**OPERATION CROSSROADS** **CONFIDENTIAL**  
Security Information

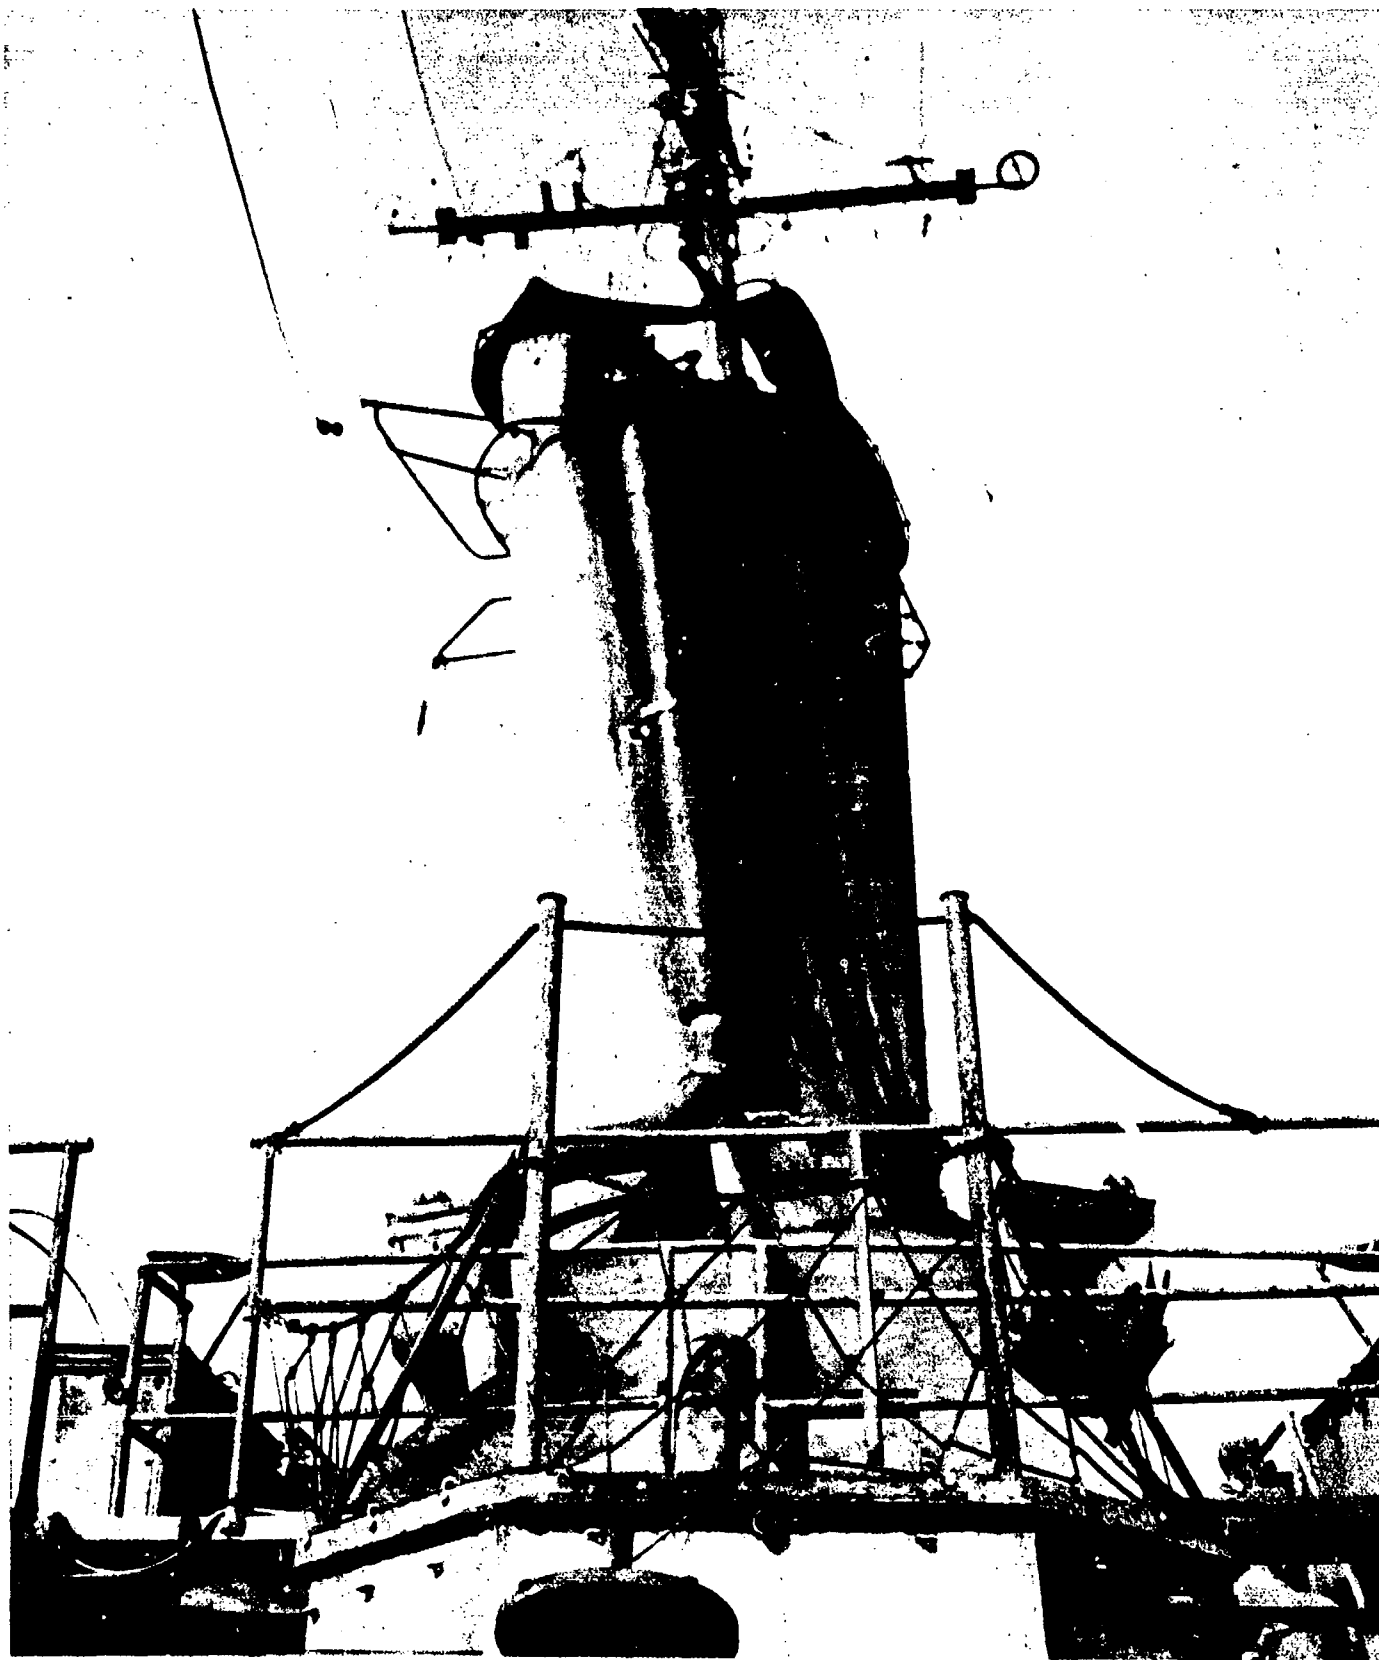
The horizontal riveted joint between the stack and fairing piece has failed for a length of about eight feet. The bottom of the stack has torn loose along the rivet holes leaving the rivets in the fairing piece in this area. Both the inner and outer casings are damaged. The after starboard guys of the foremast parted and the foremast is bent forward and to port about six degrees starting about 20 feet from the top where there is a reduction in size (Photos 2198-5, 6; pages 74, and 75). Most antennae are down. Whip antennae are badly bent but are generally operable.

AA-CR-62-2171-2. Looking forward at blast damage to stack.

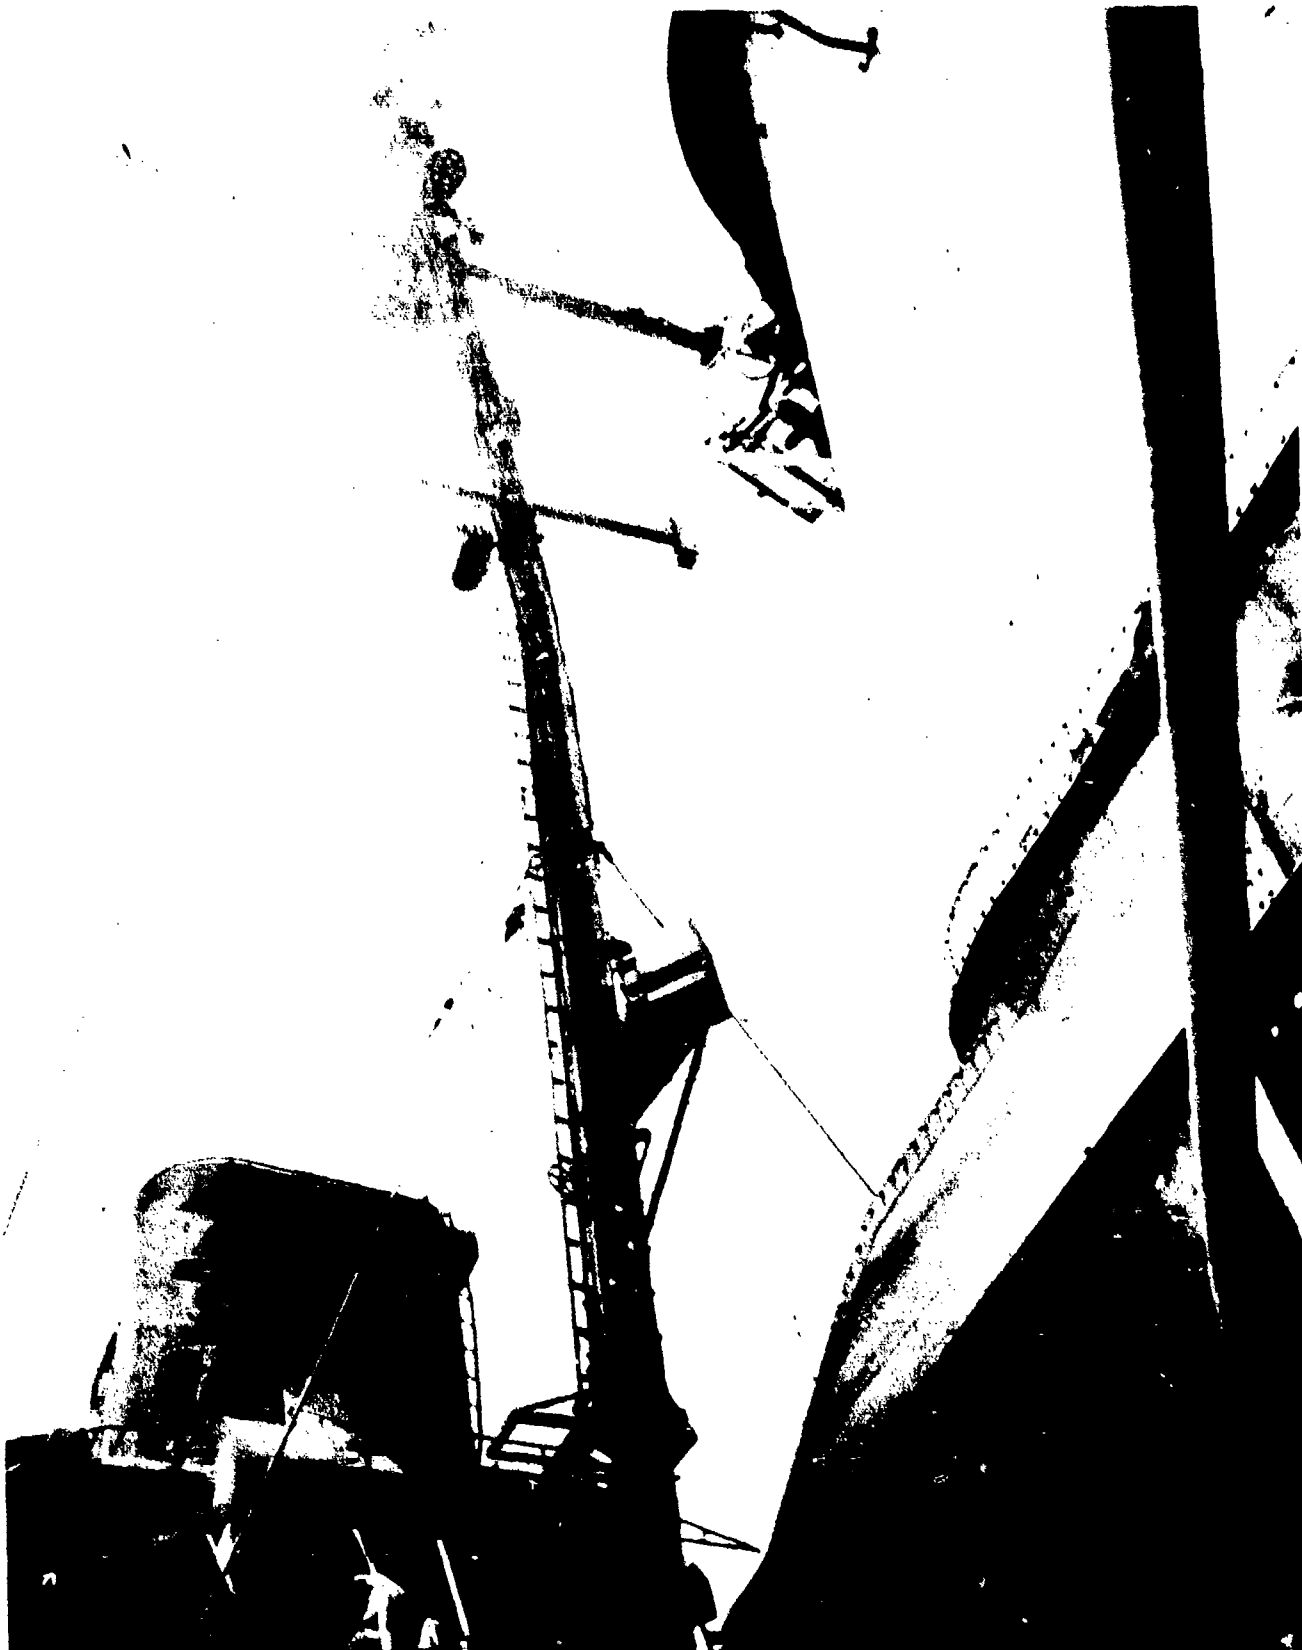
AA-CR-100-2198-5. Looking forward and to starboard at bent foremast. -

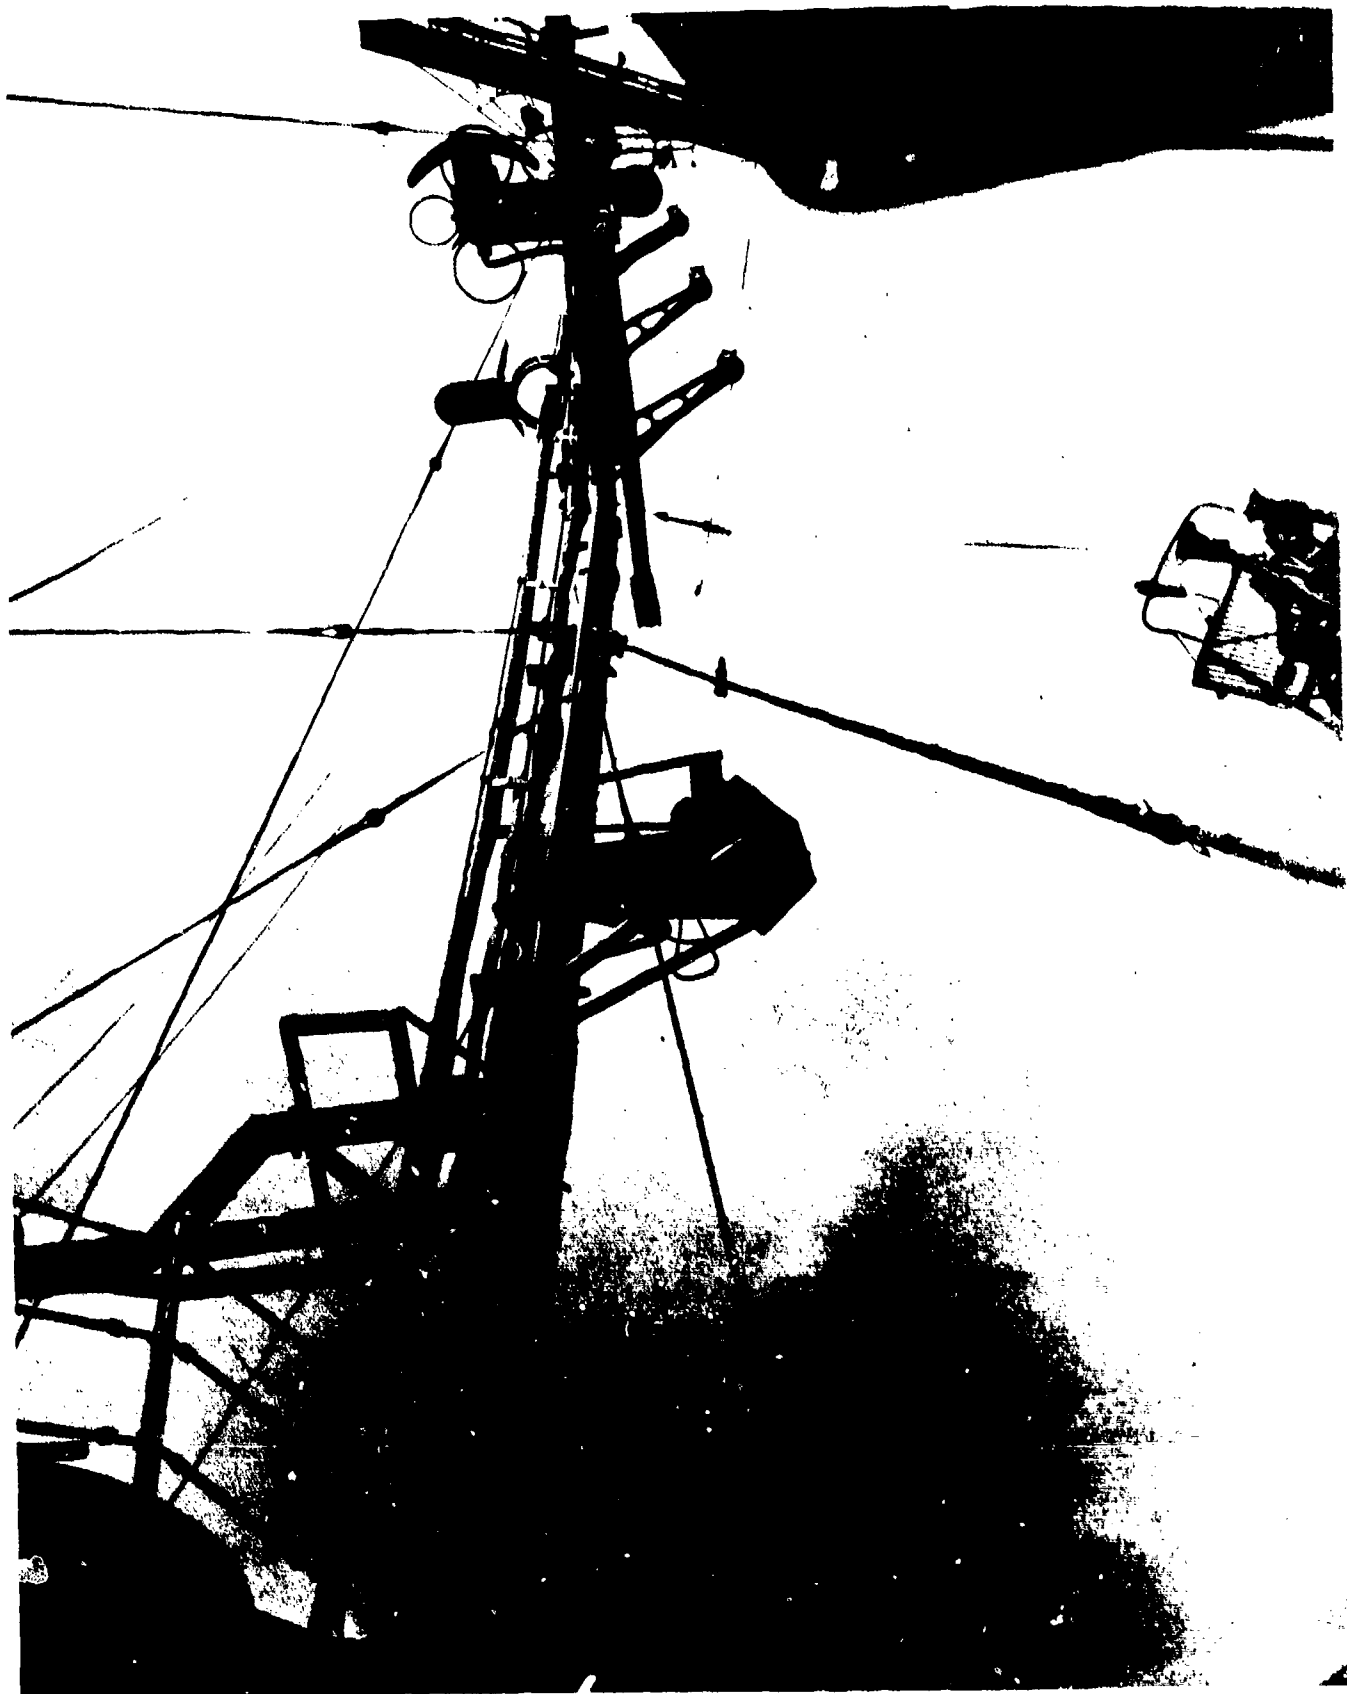
AA-CR-100-2198-6. Looking to starboard at damaged foremast.

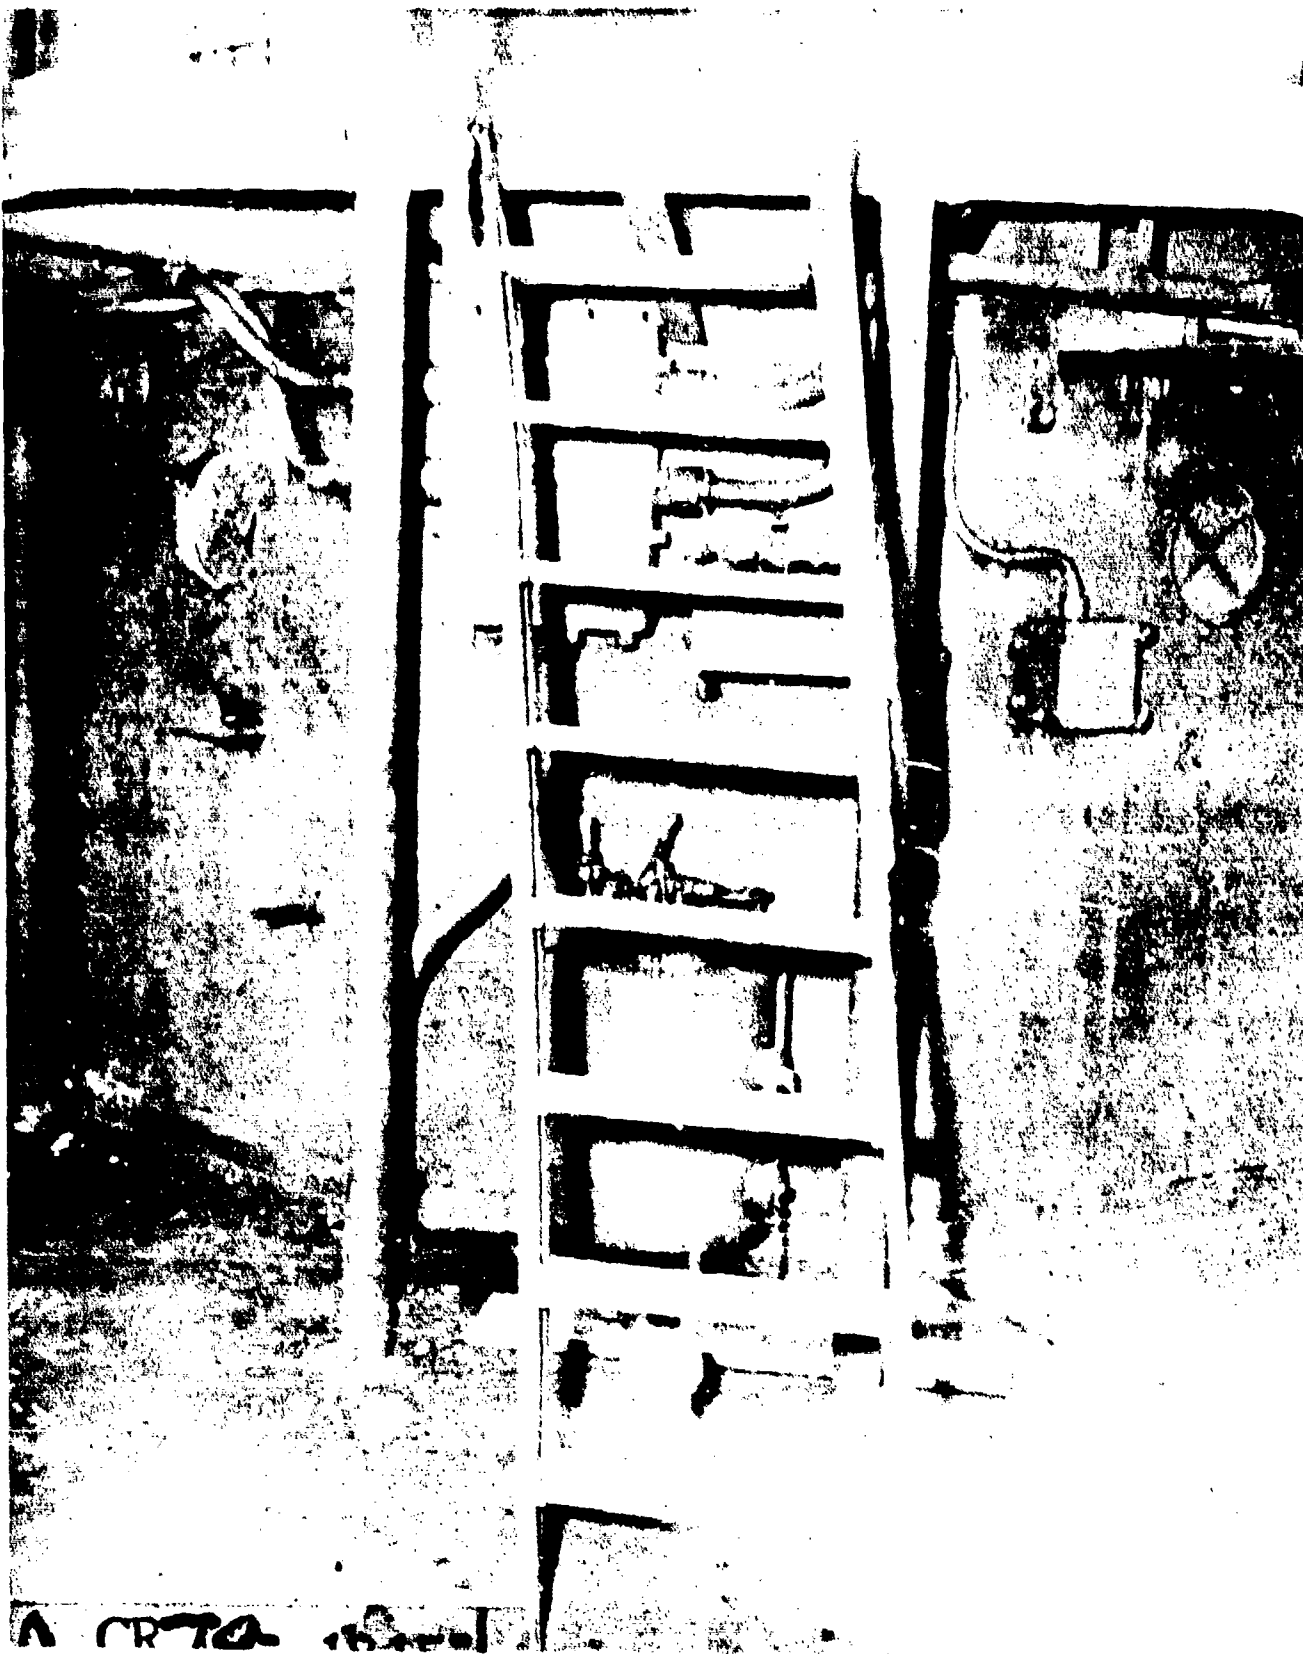
• There is a general failure of exposed sheet metal work such as flag bags, lockers, and sun shields on 20MM ready service boxes. Ladders have bent and have failed at their end connections (photo 1815-1; page 76). Bulwarks fabricated from 5 pound plate at 20 MM gun stations are dished.

AA-CR-79-1815-1. View of bent amidship ladder leading to top of after deck house, frame 130, centerline.

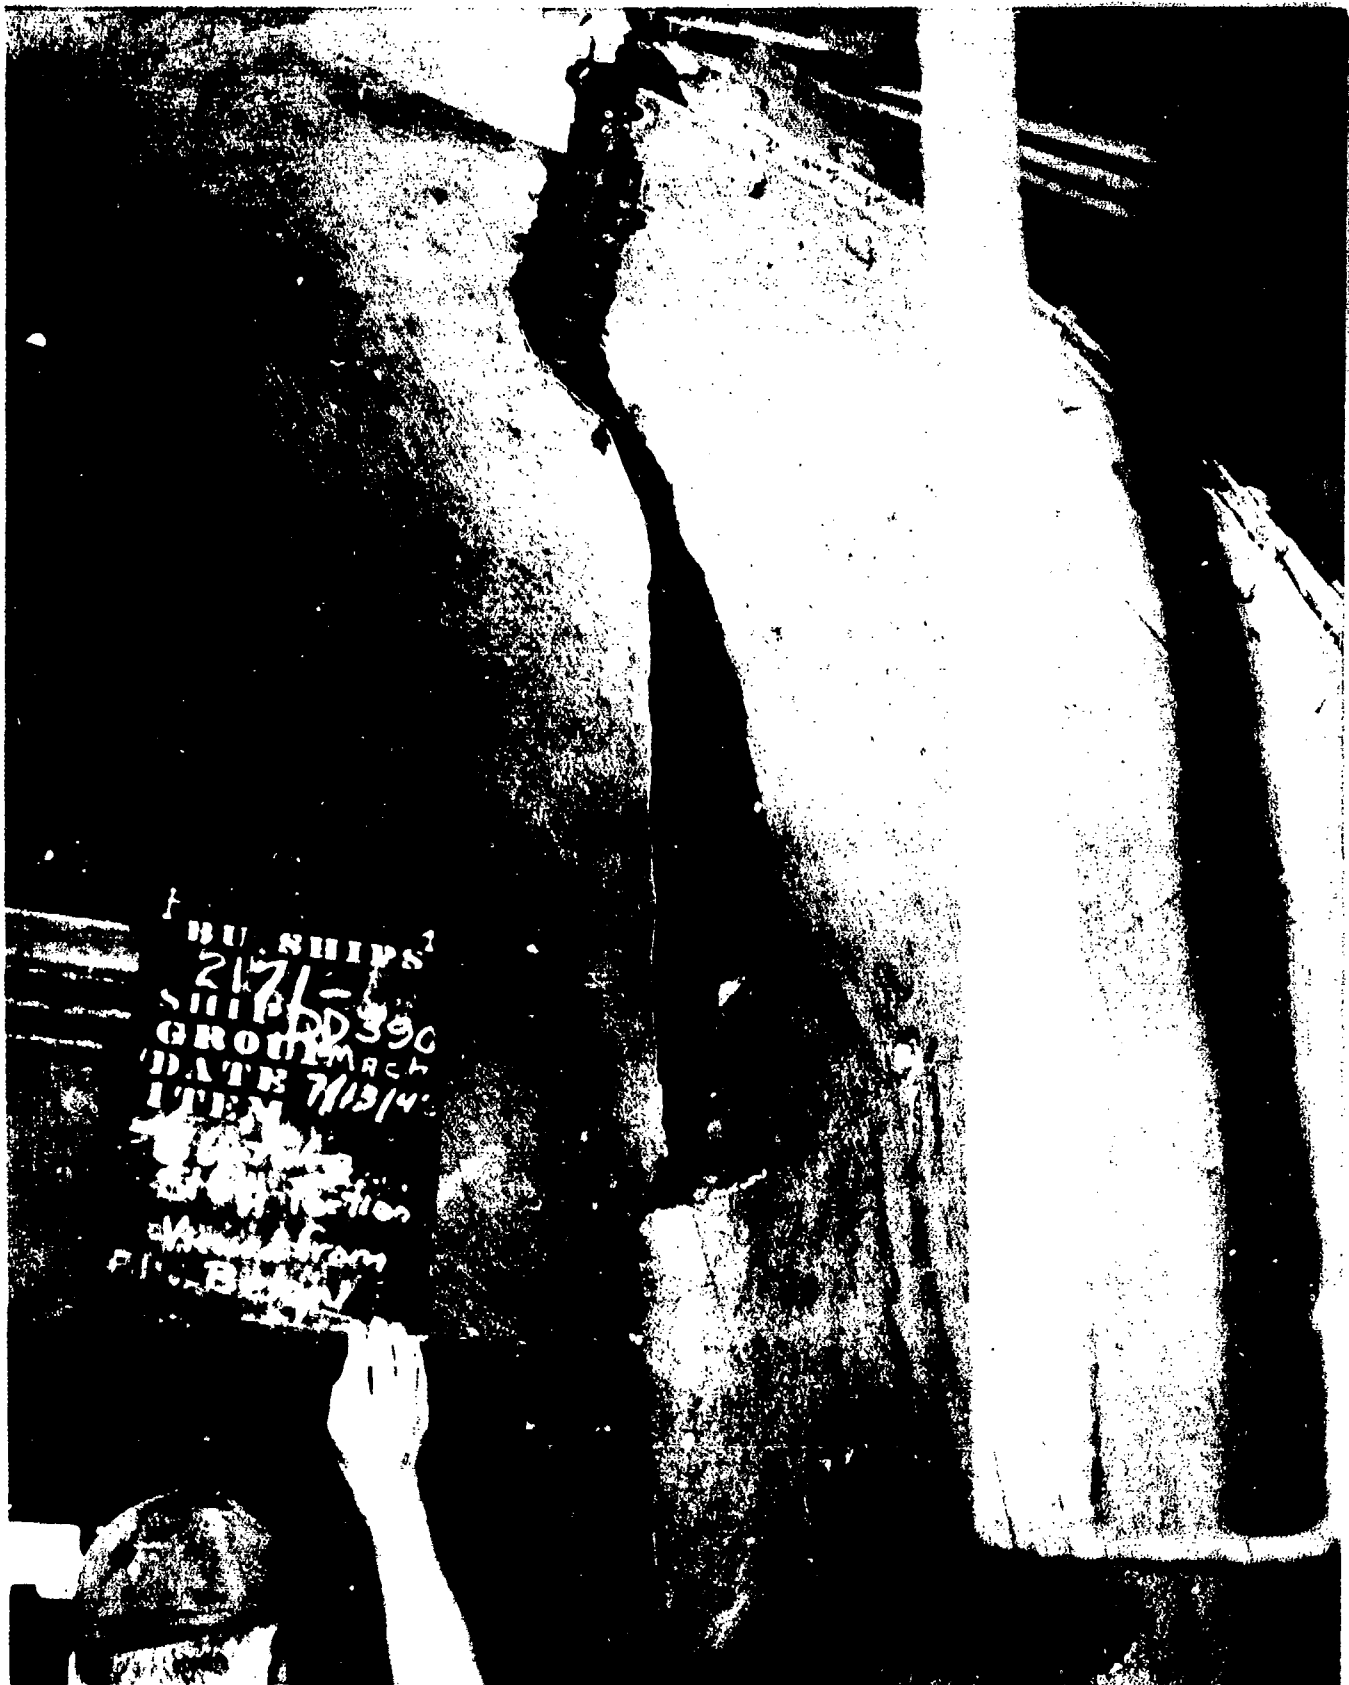
AA-CR-62-2171-8. No. 3 uptake, starboard portion viewed from below.
